Statutory Report

**REPORT INTO THE DEATH OF PAUL SOMERVILLE
ON 31 JANUARY 2012**

Volkswagen Transport Van Door and Cell Door

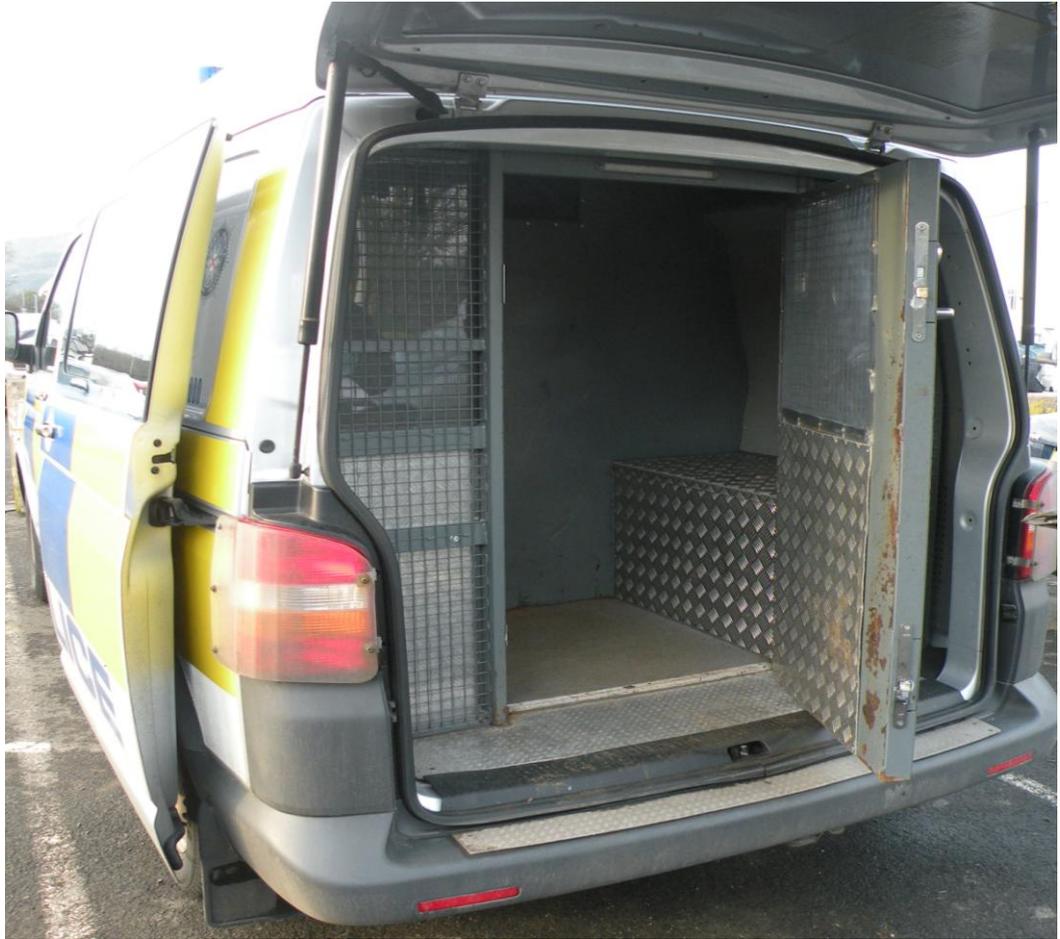
3.16

- 3.15 The cell door locking mechanism consisted of two latch bolts, upper and lower, which were operated by a single lever on the outside of the door and a dead bolt operated by the cell key with the key hole located on the outside of the rear door. The dead bolt and upper latch bolt are housed within the same unit. There is no door handle inside the vehicle in the cellular area. The dead bolt is put into position by inserting the relevant key at the 12 o'clock position and turning the key anti-clockwise to the 9 o'clock position. The key is then turned back clockwise to the 12 o'clock position, where it can be removed. It was further identified that if the key was turned but not to the full 9 o'clock position, the dead bolt would give the impression that it had fully extended when it had not.

- 3.17 The cell door mechanism was designed so that when the door is closed the spring loaded latch bolts would retract and then fall/lock into the relevant recess in the floor. When this was done the door cannot be opened without turning the door handle at the rear. It was established that if the latch bolts did not engage then the door can be opened with little or no pressure and without using the door handle.
- 3.18 When the dead bolt is engaged the door cannot be opened even if the latch bolts are not engaged properly.
- 3.19 On testing the cell door the scientist concluded that the cell door latch bolts did not always engage, even when the door was slammed, this was due to distortion/misalignment of the door and the door frame.

- 3.20 During a test the scientist entered the cell compartment and the cell door was closed. The dead lock was not applied for the test. The vehicle door was then closed. The scientist was able to open the cell door using little force. The gap between the cell door and the vehicle door was sufficient for the scientist to reach round and open the vehicle rear (hatch) door and exit the vehicle, in a very short period of time and using very little effort in the task.

- 3.21 The scientist concluded that in order for Paul Somerville to have been able to exit the vehicle one of the following three scenarios must have occurred:

1. The rear cell door had not been closed.
 2. The rear cell door had been closed but the latch bolts were not engaged or fully engaged and the key operated dead bolt mechanism had not been used.

3. The rear cell door had been closed but the latch bolts were not engaged or fully engaged and the key operated dead bolt had been used but the bolt was not extended sufficiently to engage fully.

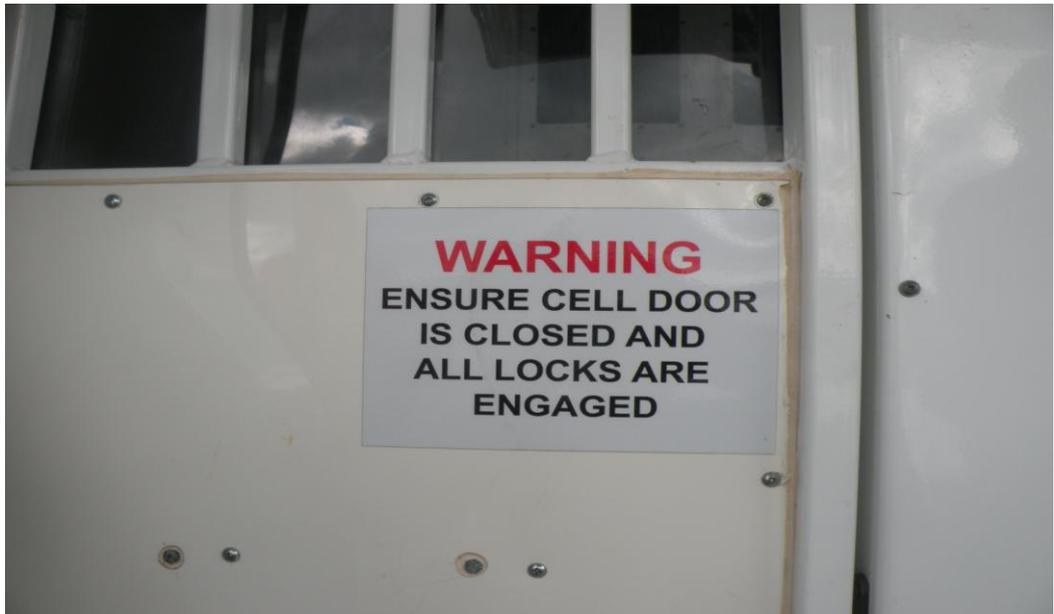
5.4 The Police Ombudsman has recommended that a potential fault in the latch bolt locking mechanism of Volkswagen Transport Cell vehicles could represent a risk to health and safety and should be brought to the attention of the PSNI. The PSNI has acted upon this recommendation. It has fixed display notices to vehicle cell compartments, informing officers of the need to ensure that doors are fully locked. Furthermore a 'blanking' panel was placed over the vehicle's rear door so as to prevent it being opened from the inside.

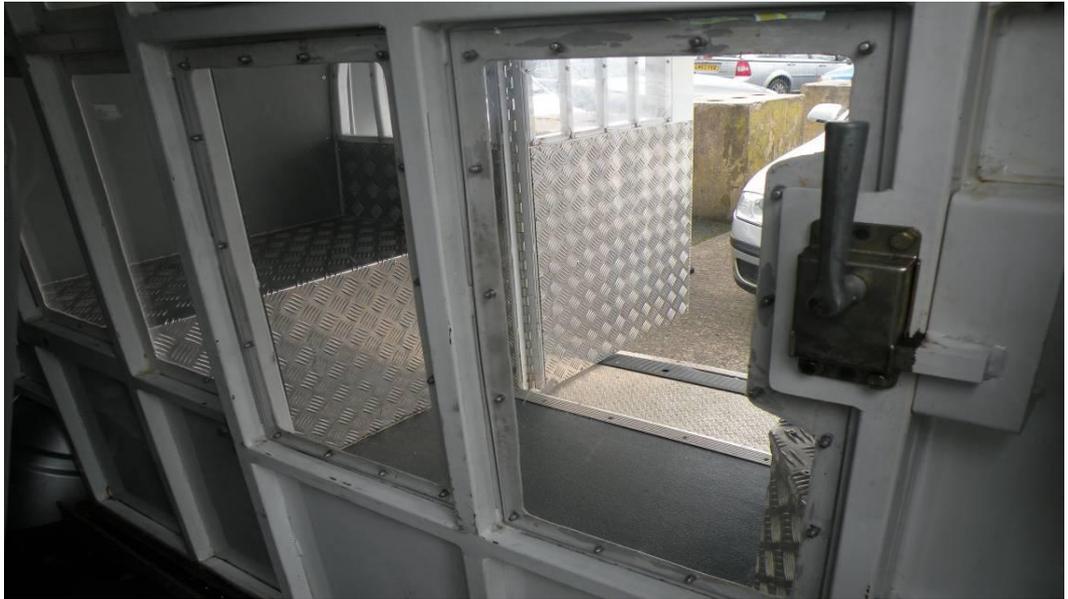
The Police Ombudsman has recommended that the police review the specifications of the Volkswagen Transport cell vehicles to better allow for the appropriate monitoring of prisoners. The PSNI has now fitted all its Transport cell vans with clear Perspex to allow for easier monitoring and observations of detainees. While the cell door design is still widely used across the UK and fitted to new vehicles by the manufacturers, the PSNI intend sharing the findings of this case with other forces.
